Horse Creek Stream Digitization

By: Colton Sorensen
Eric Wojchik

Reasoning for Digitization

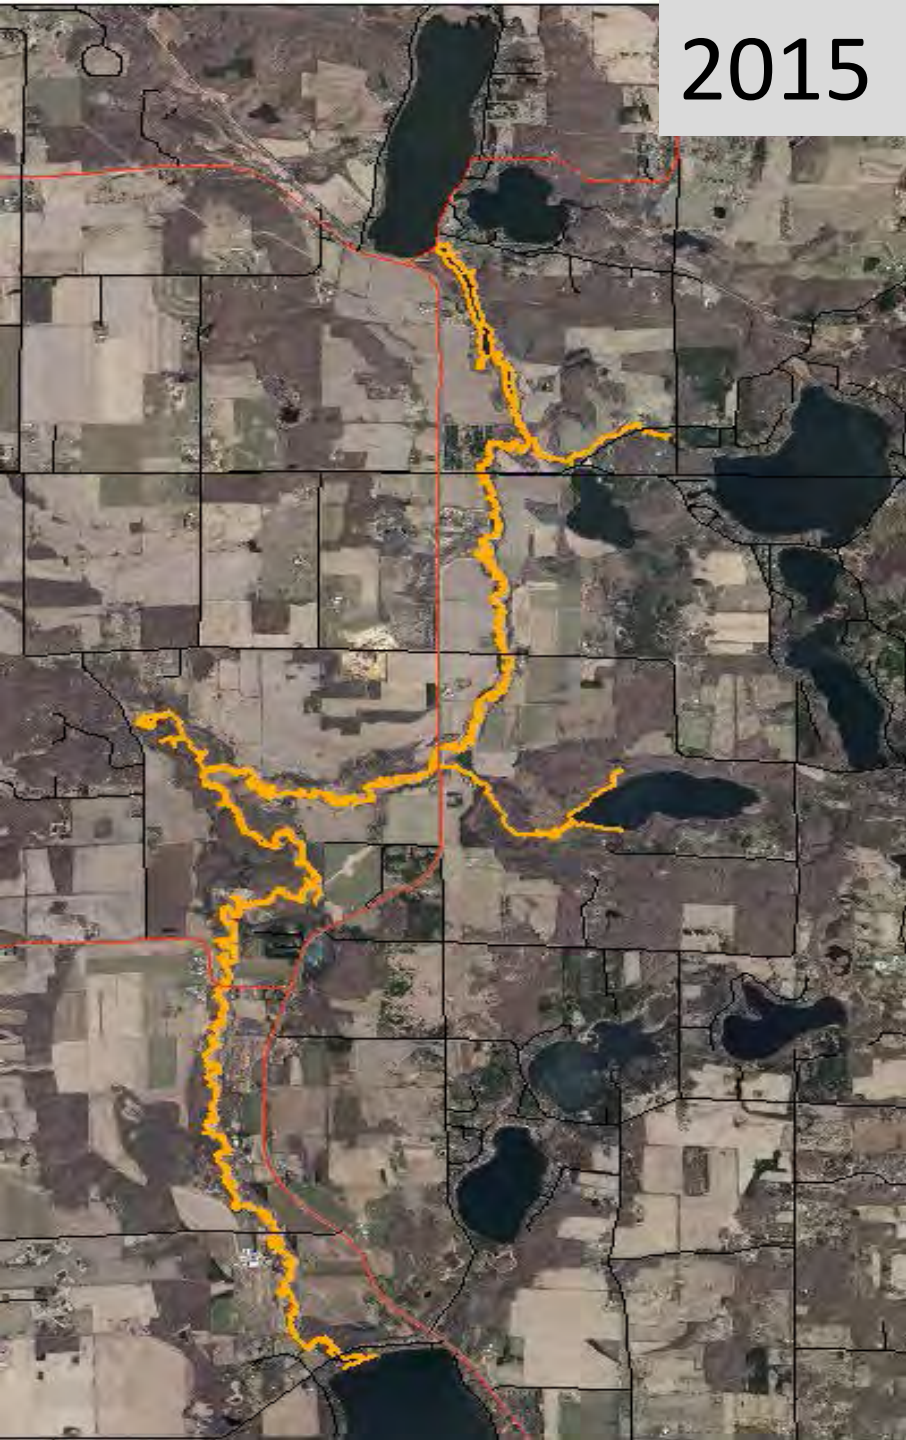
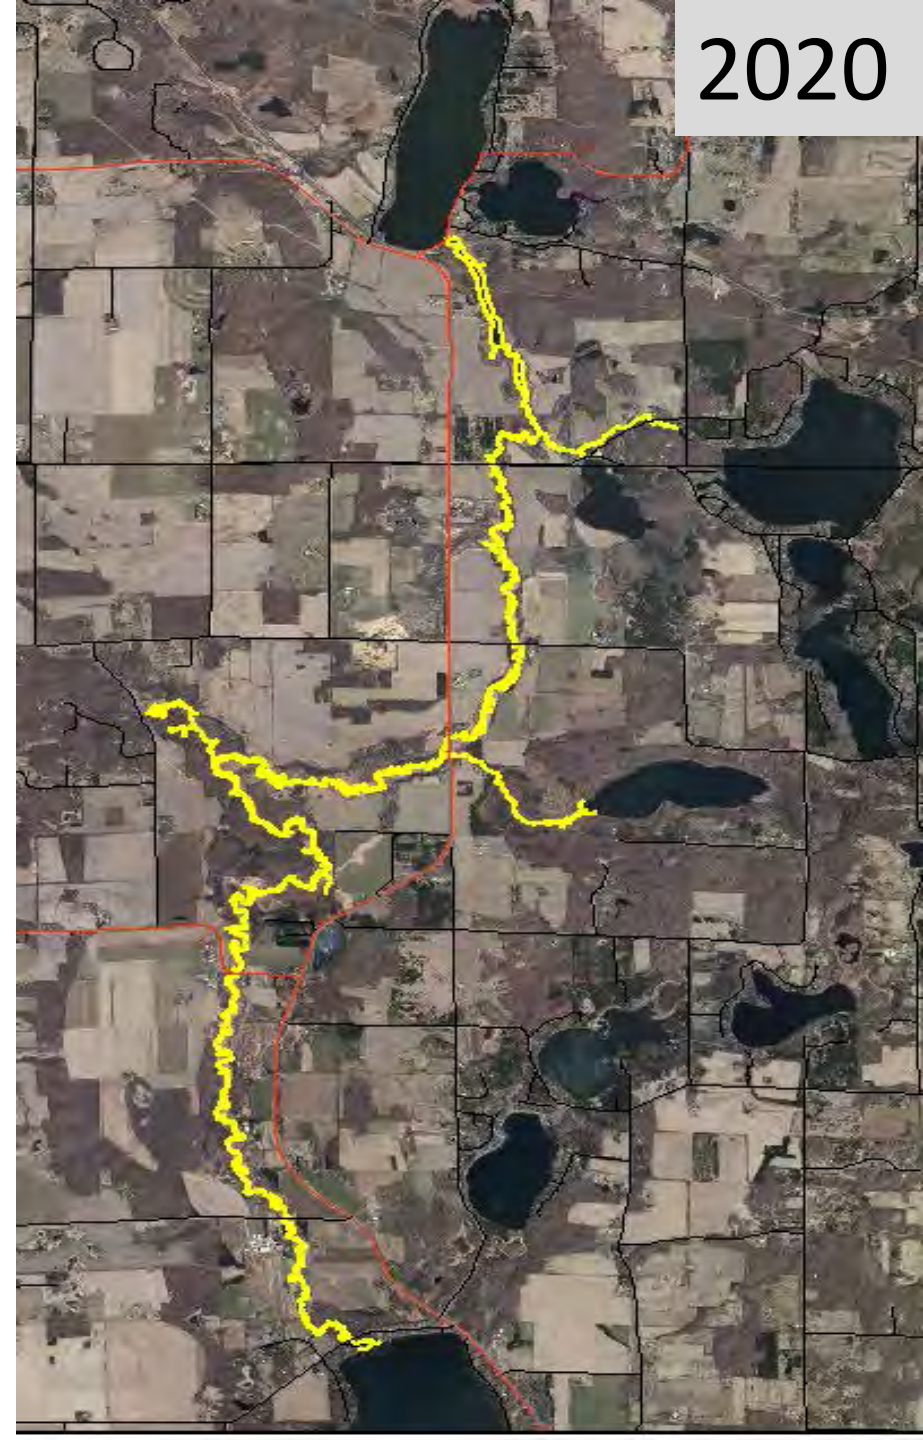
- The orange and yellow lines depict digitized flow paths.
- The main tributary's entering the stream were also digitized.
- 2015 aerial photo will always be on the left and 2020 will be on the right
- All side by side comparison photos are at the same scale.
- Each of the following slides show significant changes in the flow path.

- The left photo is the 2015 aerial photo(background image) with the orange line being the waters edge in 2015.
- The right photo is the 2020 aerial photo (background image) with the same orange line located where the banks of the stream were in 2015.
- This shows that the channel has gotten smaller in the last 5 years. Specifically at the circled areas.

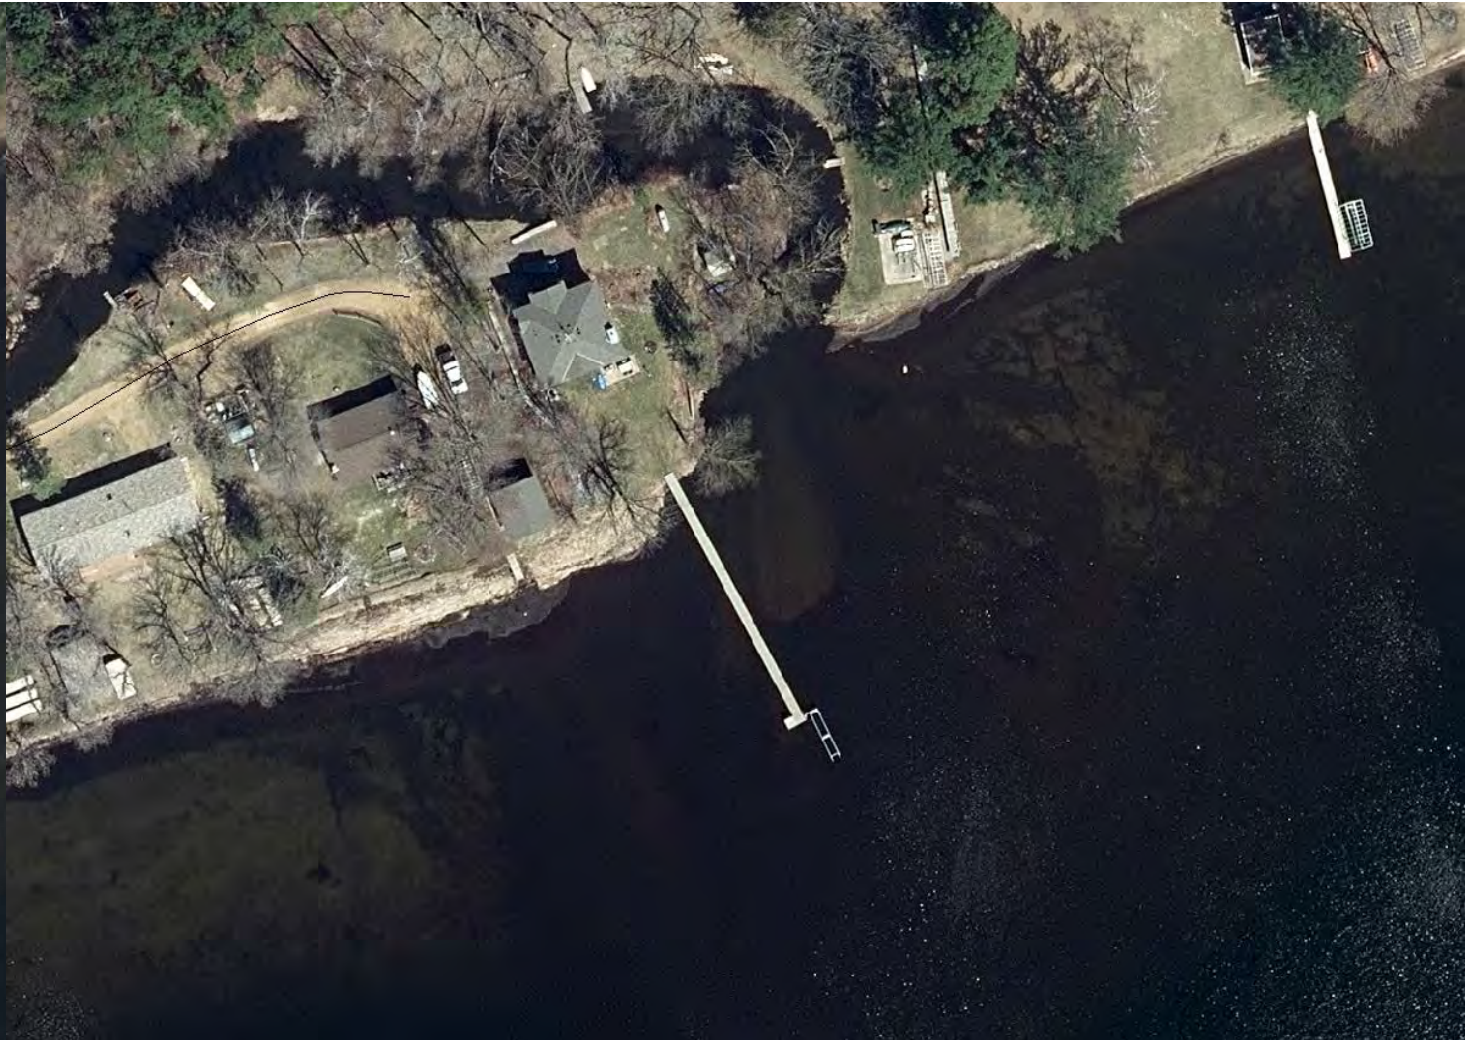
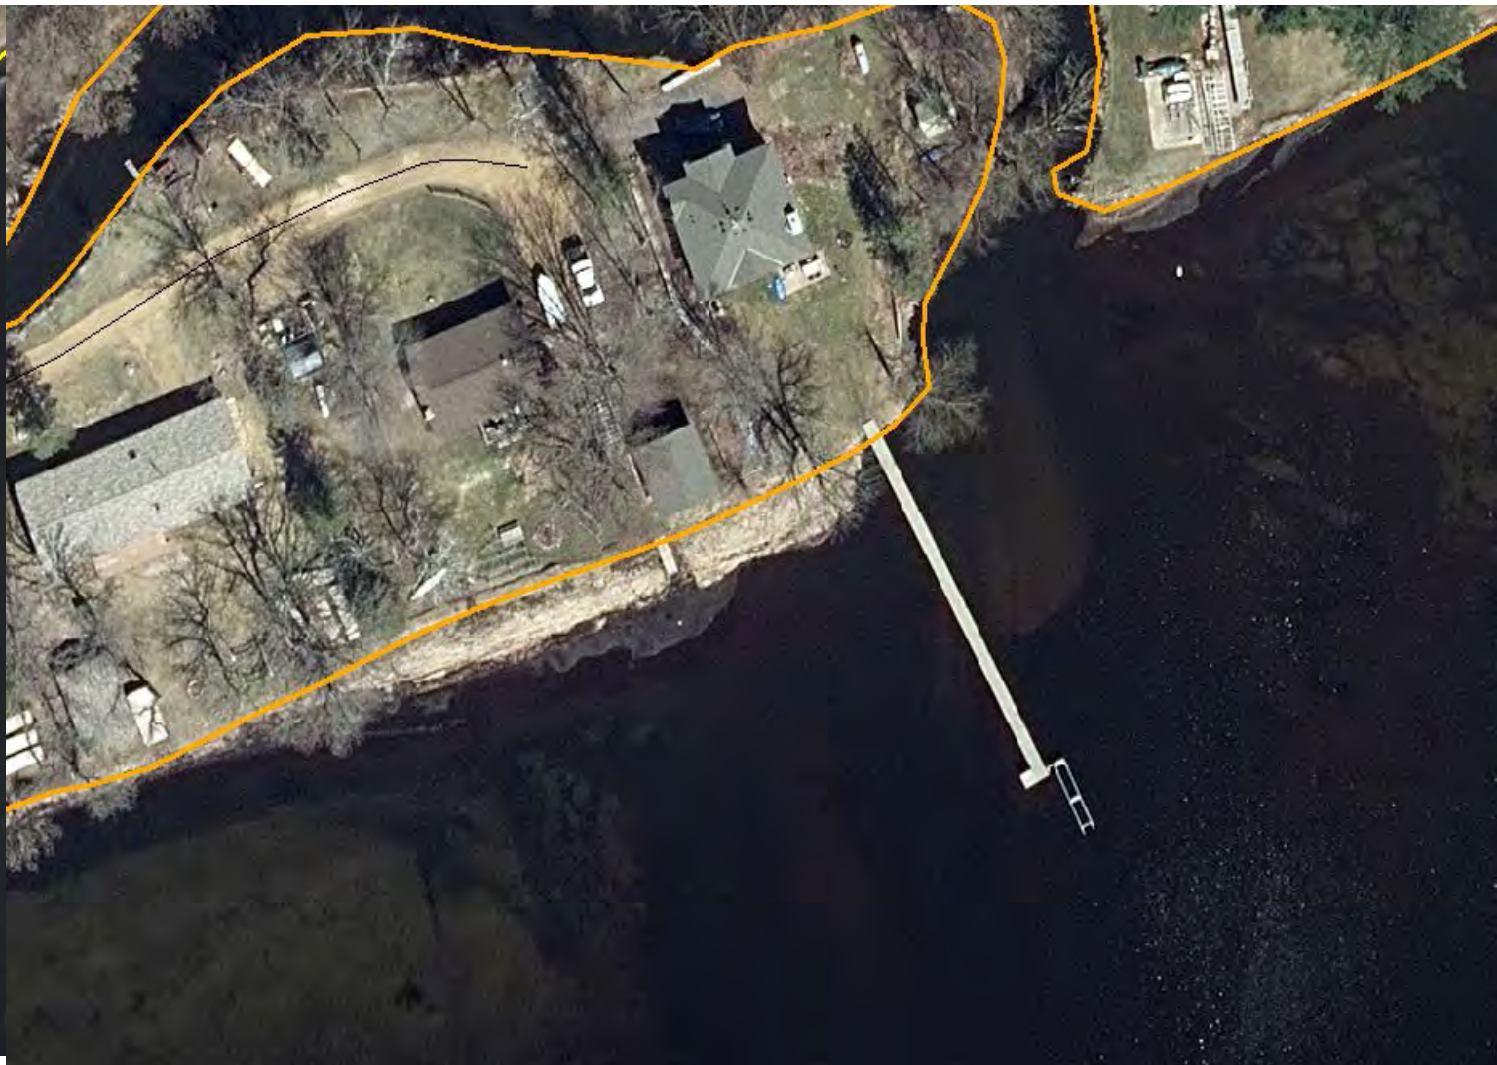
2015 Aerial With 2020 Shoreline (Yellow)

2020 Aerial With 2015 Shoreline (Orange)
