Cedar Lake, St. Croix County, WI, AIS Surveys-June, July 2023

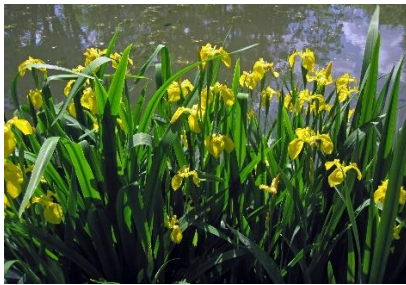
Yellow iris-*Iris pseudacorus*

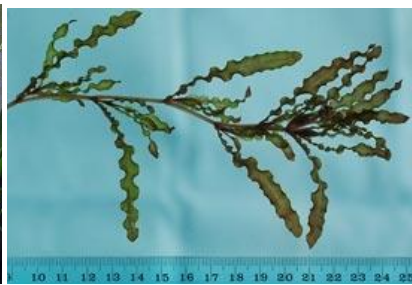
Curly-leaf pondweed-*Potamogeton crispus*

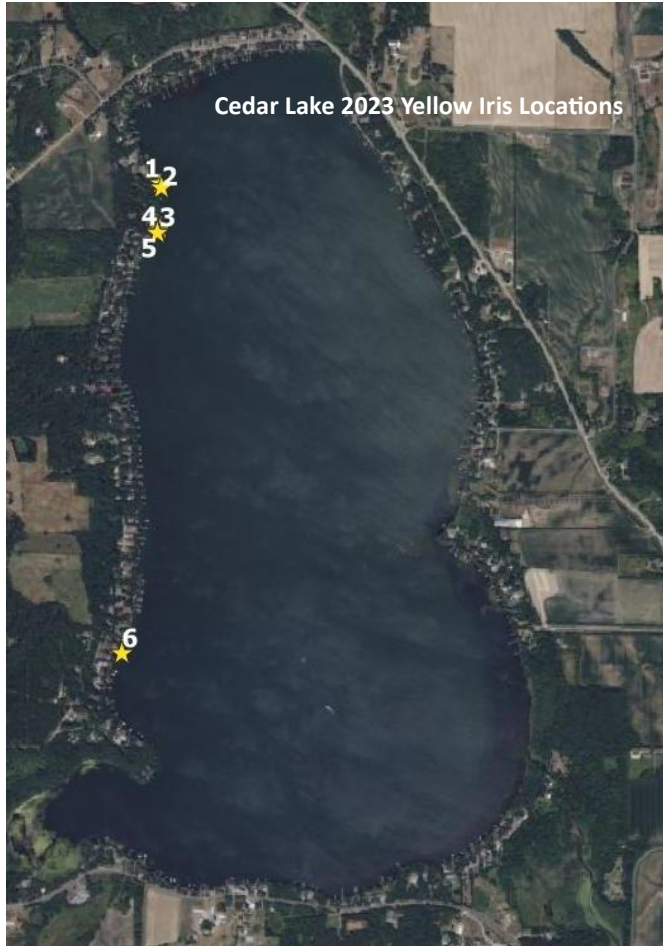
Yellow iris locations are shown in the map below:

Yellow Iris Site	Latitude	Longitude
1	45.226586	-92.57876
2	45.226429	-92.578717
3	45.224939	-92.578832
4	45.224839	-92.578915
5	45.224783	-92.578943
6	45.209454	-92.580884

All locations had a small number of plants and did not occur as beds of yellow iris.

Recommendation: Hand removal or herbicide application should be considered so these plants do not spread to wetland areas such as in the southwest portion of Cedar Lake.

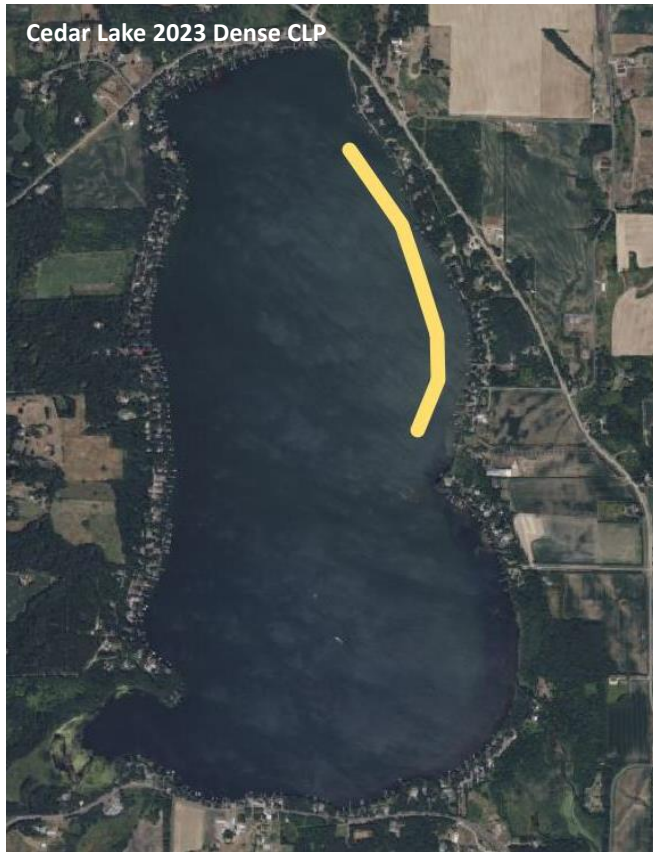
Curly leaf pondweed was observed in many areas of Cedar Lake. The yellow marker on the map below shows where CLP was observed to be very dense and reaching the surface. This area has extensive coverage of CLP that could reduce navigation with boats due to the density and growth at the surface, where motor props can encounter it. The CLP was not mapped due to the large areas. CLP can vary extensively from year to year.

Recommendation: Continue monitor and consider mitigation if determined to be an annual nuisance for the use of Cedar Lake. CLP has been documented in Cedar Lake for many years and was not an emphasis in the management plan, likely due to an established population that has not been deemed a significant issue for Cedar Lake.

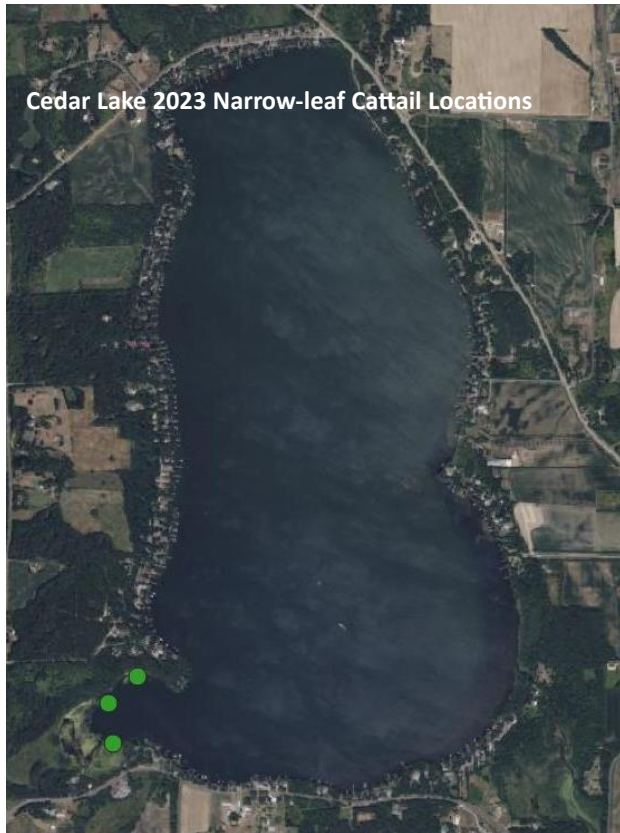
Narrow-leaf cattail was observed in the southwest bay of Cedar Lake. There are some rather large beds of this plant present. It has likely been established for many years in Cedar Lake. Although considered a restricted invasive species in Wisconsin, mitigation does not typically occur unless there is evidence it is a new introduction into a native cattail bed. Narrow cattail is very common in many lakes and wetlands in Wisconsin.

The green dots on the map below show where some beds were observed. The plant's beds were not mapped.

Recommendation: Continue to monitor for new areas if this is a concern; otherwise, it is likely growing where it can in Cedar Lake, as it has probably been present for several years.
